Official Accident Report Index Page

Report Number	NTSB-AAR-79-17
Report Title	American Airlines, Inc. DC-10-10, N110AA, Chicago-O'Hare International Airport Chicago, Illinois, May 25, 1979
Report Date	December 21, 1979
Organization Name	National Transportation Safety Board Bureau of Accident Investigation Washington, D.C. 20594
WUN	2662-E
Sponsor Name	NATIONAL TRANSPORTATION SAFETY BOARD Washington, D. C. 20594
Report Type	Aircraft Accident Report May 25, 1979
Distribution Status	This document is available to the public through the National Technical Information Service, Springfield, Virginia 22151
Report Class	UNCLASSIFIED
Pg Class	UNCLASSIFIED
Pages	103
Keywords	DC-10; loss of control; asymmetrical stall; stall warning system; slat disagreement warning light; structural separation; No. 1 engine and pylon; design criteria; maintenance procedures; FAA regulations; industry communications procedures.
Abstract	<p>About 1504 c.d.t., May 25, 1979, American Airlines, Inc., Flight 191, a McDonnell-Douglas DC-10-10 aircraft, crashed into an open field just short of a trailer park about 4,600 ft northwest of the departure end of runway 32R at Chicago-O'Hare International Airport, Illinois

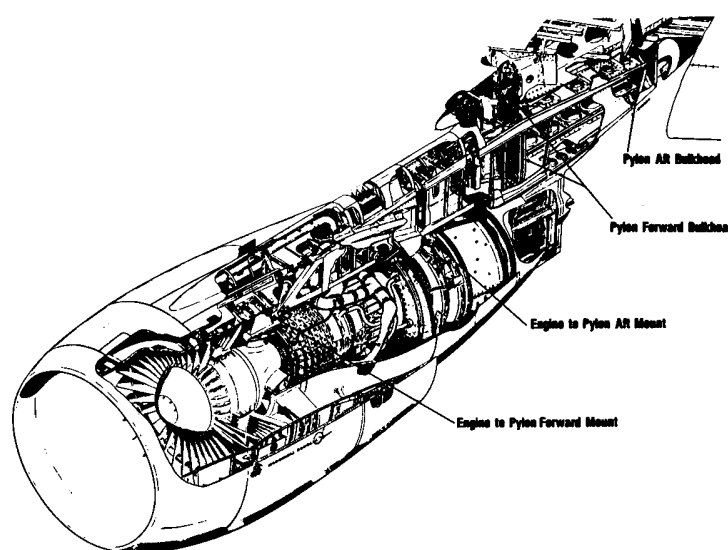
Figure 2. Engine and pylon assembly.

The pylon forward bulkhead was bent forward about 30° and most of the bolts which held the bulkhead upper plates were missing. The upper 12 inches of the forward plate were bent forward an additional 10° to 15°. The aft plate was broken below the thrust fitting connection, and a large piece of the upper left corner was missing.

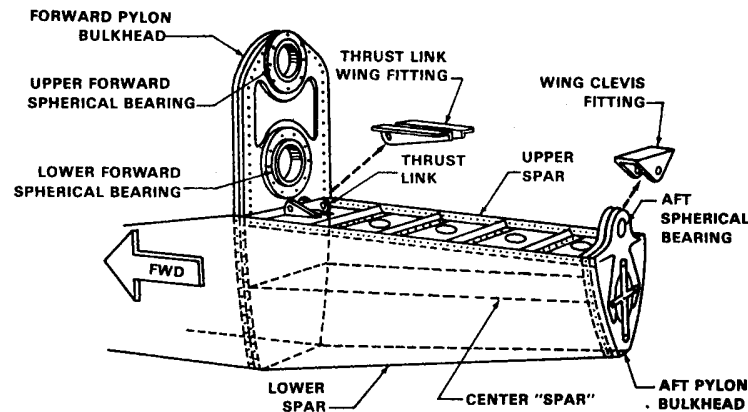
Figure 3. Pylon assembly.

The wing's forward support fitting, which attached the pylon forward bulkhead to the wing at the upper and lower plugs and spherical bearings, was found at the main wreckage site. The upper and lower plugs and their attaching hardware were intact, and the upper and lower spherical bearings were attached to the fitting.

The pylon thrust fitting remained attached to the forward portion of the pylon's aft upper spar web. The pylon thrust link, which attached the pylon thrust fitting to the wing thrust angles, was found at the main wreckage site attached to a portion of the wing thrust angles. Its forward spherical bearing was cocked to the extreme left, and a segment of the bearing which had broken away was found on the runway.

The thrust bushing bolt had broken in two parts, both of which were found in the grass adjacent to the runway. The bolt nut was attached to one of the broken pieces, and the faces of the nut were gouged severely. Except for one lubrication retainer washer, which was not found, the remaining portions of the thrust bushing bolt assembly were found along the runway. One shim spacer from the assembly was crushed severely while the other was relatively undamaged.

The upper two-thirds of the pylon aft bulkhead separated from the flanges around its periphery and was found in the wreckage. The top two pieces of its attach lugs had separated from the bulkhead, and the aft side of the bulkhead was gouged heavily near the lower edge of the wing clevis lug, which attached the aft bulkhead to the wing. The wing clevis was attached to the wing. The aft bulkhead's spherical bearing was attached to the clevis, and the separated pieces of the aft bulkhead's attach lugs were found on top of the spherical bearing.

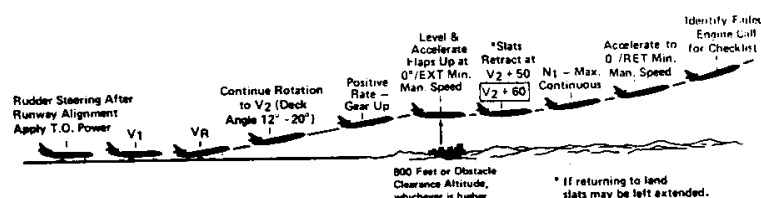
Figure 14. Diagram of AAL emergency procedure.

This procedure assumes indication of engine failure where the take-off is continued. Each take-off should be planned for the possibility of an engine failure. Normal take-off procedures ensure the ability to handle an engine failure successfully at any point.

If an engine failure occurs when making a Standard Thrust take-off, Standard Thrust on the remaining engines will produce the required take-off performance. If deemed necessary, the remaining engines may be advance to Maximum Take-Off Thrust.

On July 23, 1979, American Airlines issued Operations Bulletin No. DC-10-73 which amended the procedure. The bulletin states, in part:
